**LAKELAND CITY HALL
CAPITAL NEEDS ASSESSMENT
(CNA AUDIT)**

DATE	JULY 15 th , 2016
NUMBER	20162641

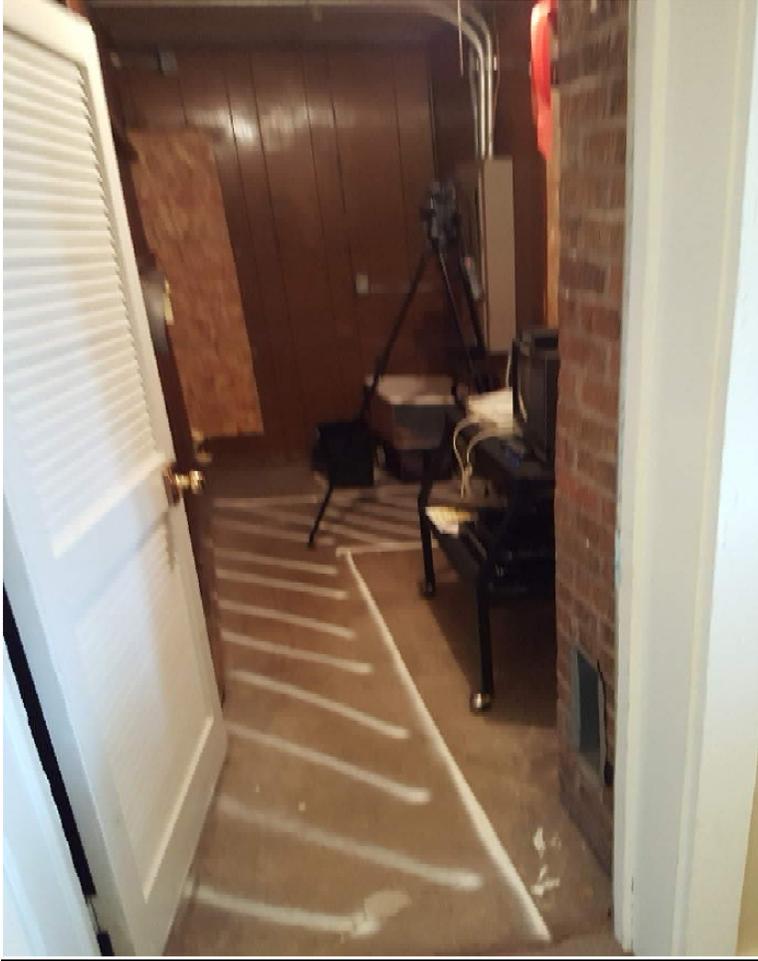
Electrical Room

- a. The electrical infrastructure appears to be acceptably modern. The room where the panel is housed is poorly laid out, making access difficult and proper clearances are not evident, as the room is also used for storage.
- b. Recommended Action: Remove all storage items from room. Ensure that all proper clearances can be met. Provide rooms signage and door hardware appropriate for space.
- c. Time Frame: TBD
- d. Opinion of Probable Construction Cost: \$500.
- e. See image #1, 2, 3.

Floor clearance concerns. Door hardware potential issue.

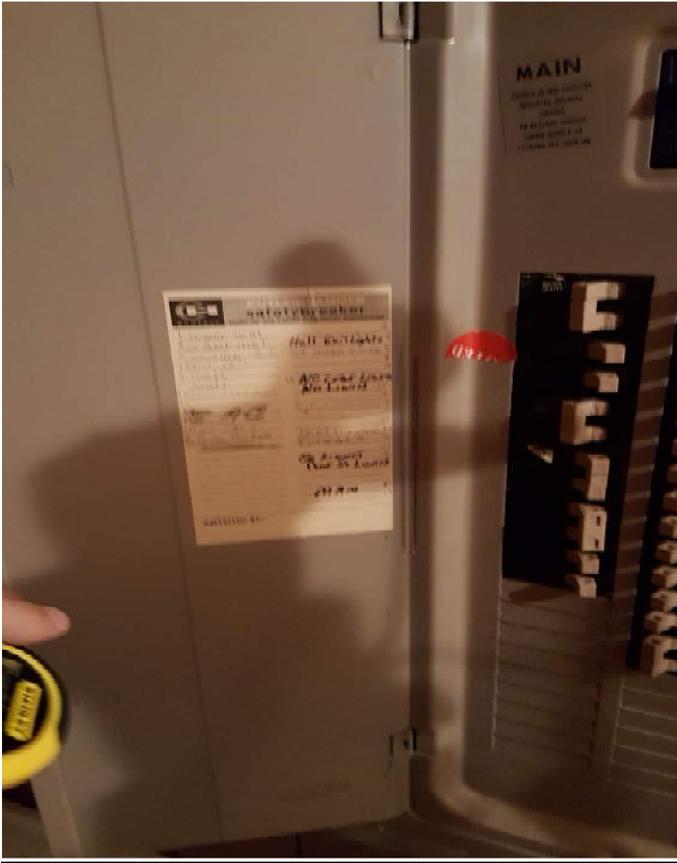
Electrical Panel

Appears sufficiently modern.

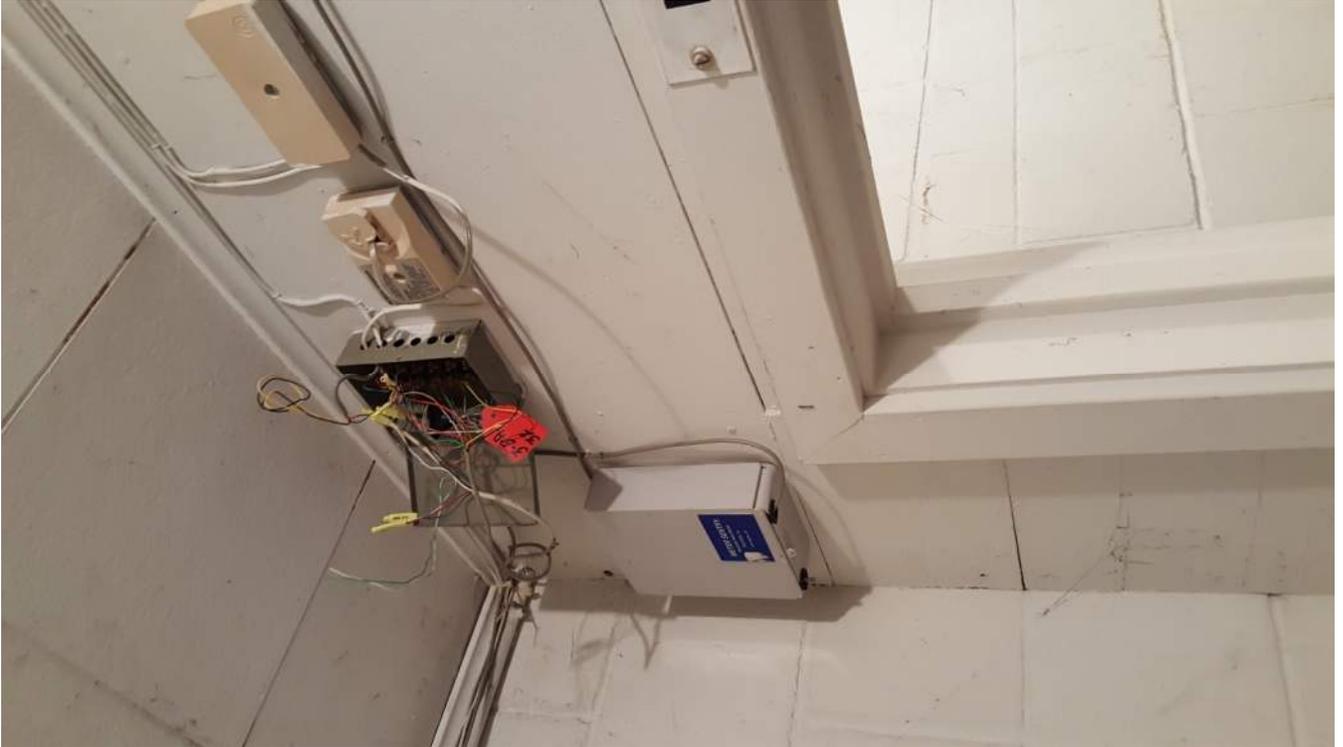
Telephone

- a. Unused telephone and other electrical or HVAC items should be permanently removed from the space. See image #4.

Abandoned systems should be removed. Systems in use should be properly protected and/or terminated in boxes.

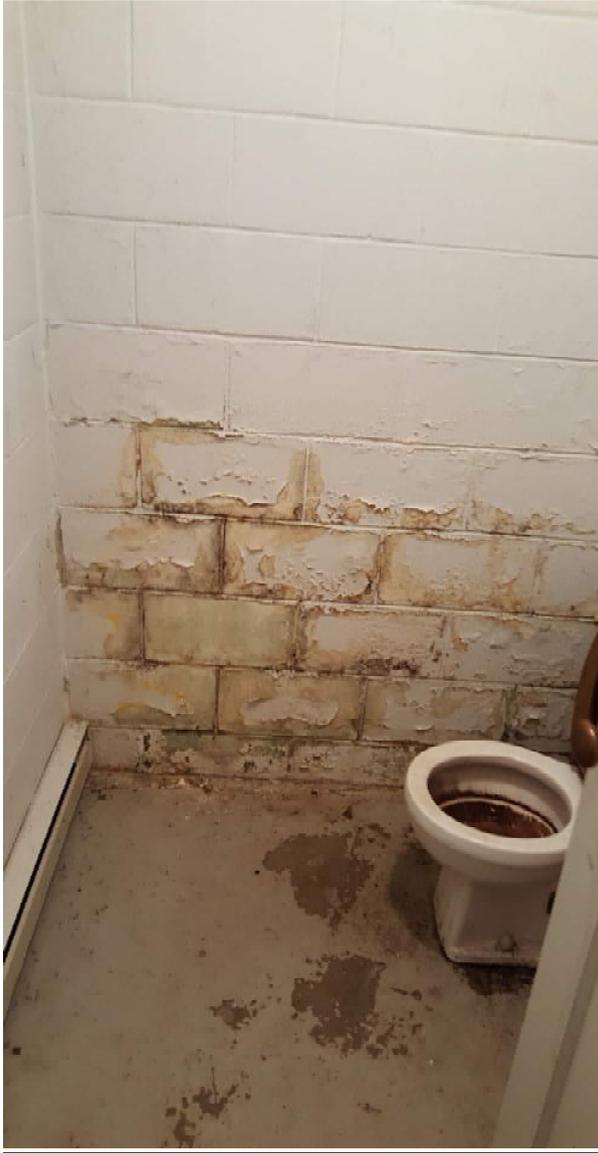
Bathroom

- a. The lower level restrooms area damaged beyond repair. There is evidence of significant water damage to the exterior masonry wall, which likely correlates with both the lack of drain tile and the damage to the roof above this area. The fixtures are all stained/damaged beyond repair and warrant replacing. There is no flooring in these spaces. Neither restroom has grab bars or the space to comply with ADA clearances.
- b. Recommended Action: Renovate lower level to include 2 ADA compliant restrooms.
- c. Time Frame: At time of anticipated occupancy of lower level.
- d. Opinion of Probable Construction Cost: \$25,000.
- e. See image #5, 6.

Fixtures damaged beyond repair. Significant water damage through wall and roof in this area. Potential for structural issues with CMU wall. ADA space clearances not available or met.

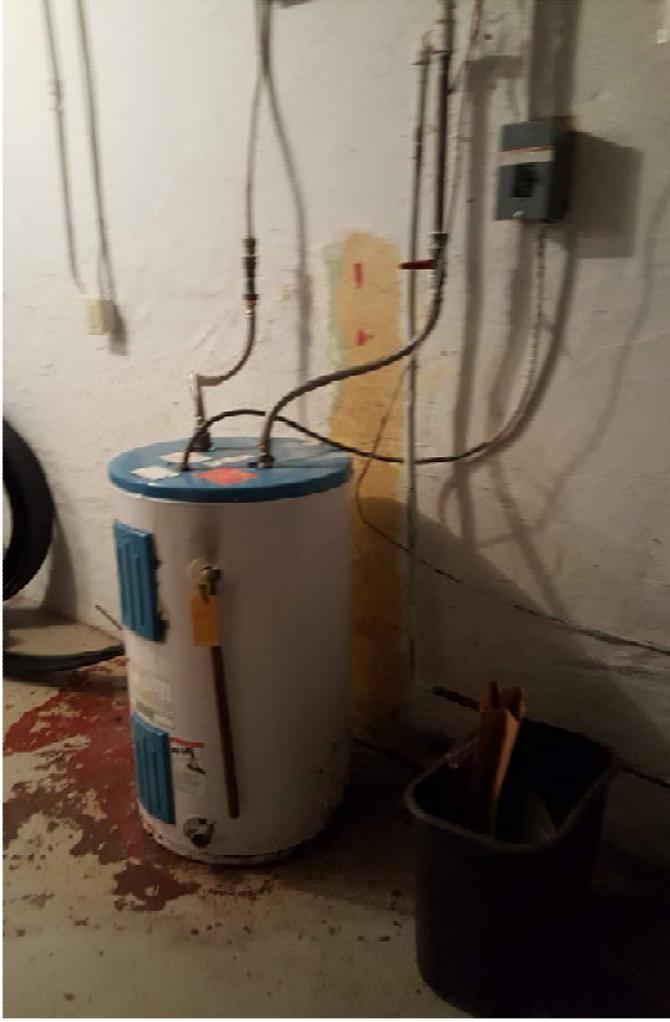
Water Heater

Exposed to storage space with all surface mount connections. If lower level is occupied, this needs to be enclosed in a building systems room.

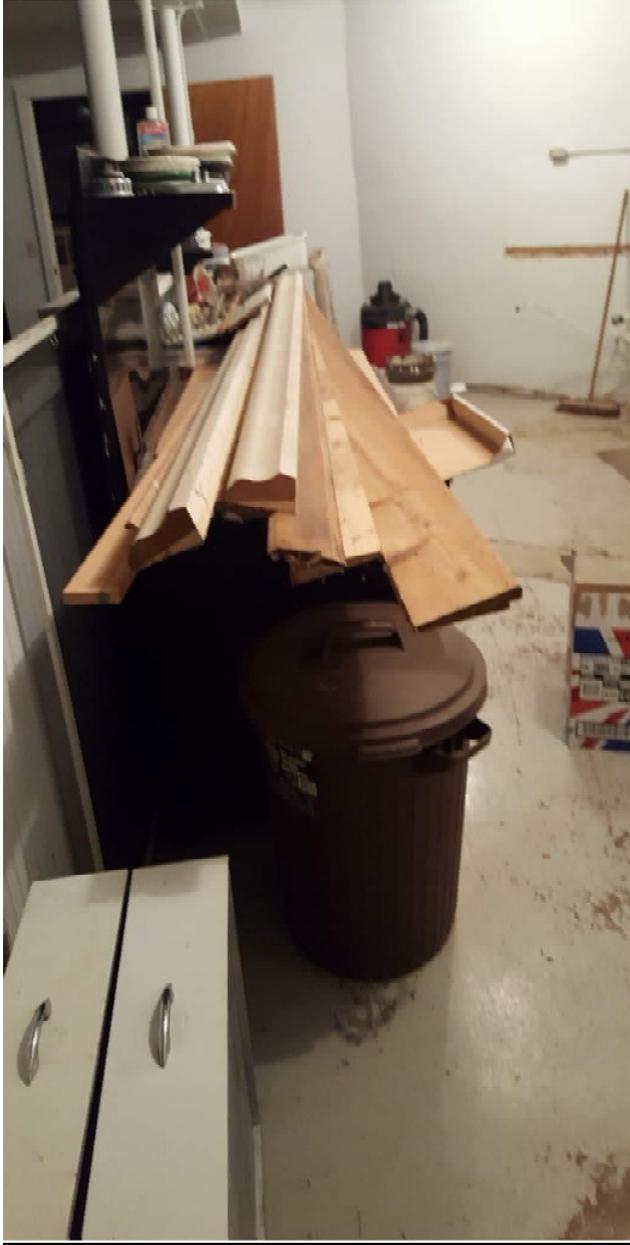
Lower Level Open Space

Storage of a variety of items. No finishes present in this space.

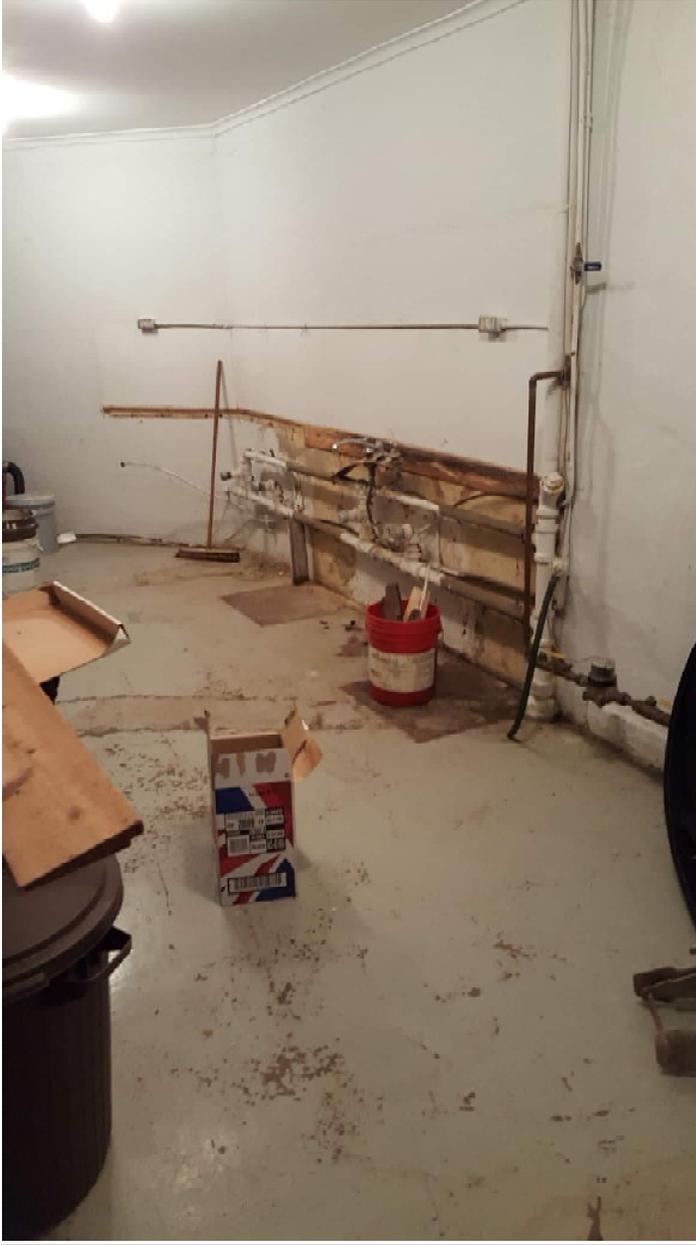
Lower Level Open Space

Exposed piping on south wall. Exposed electrical throughout.

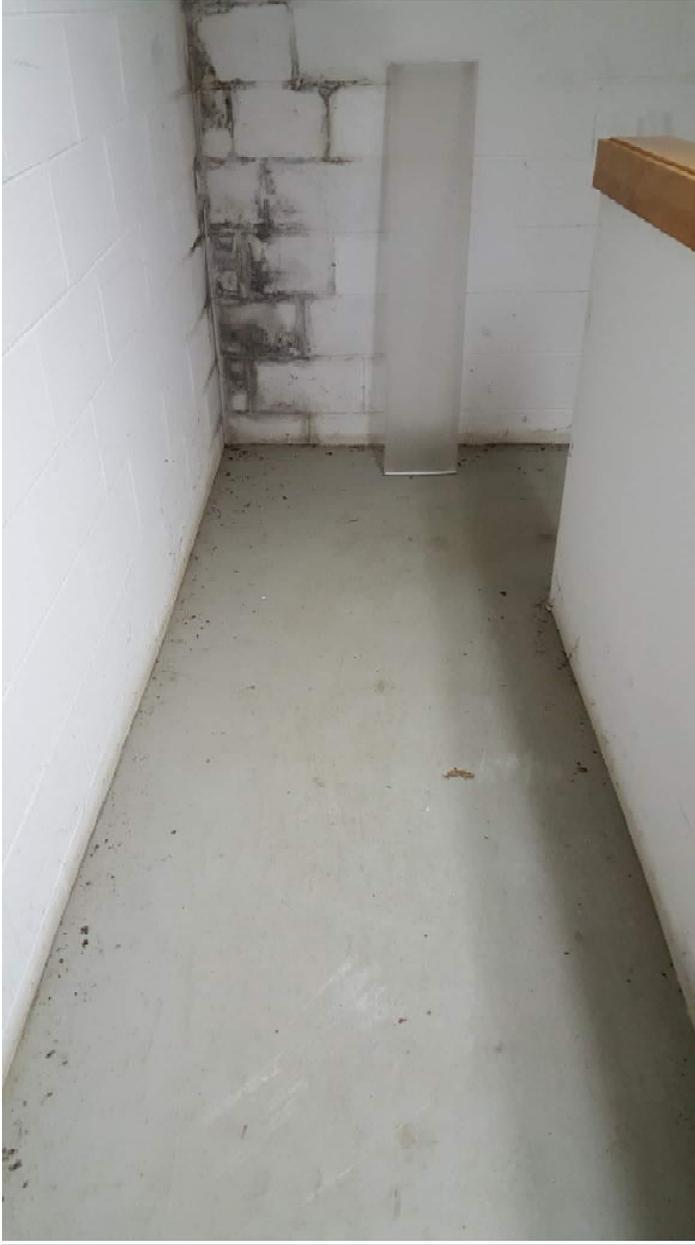
Lower Level Circulation

- a. The stairs and ramp to access this space are both deficient. The ramp is not wide enough along its route, and does not have the proper transition space at change of direction. There is not paved surface from the exit door to a parking space or area of refuge outside of the building. In addition to the functional challenges, there is significant black mold present at the foundation wall along the south end of the ramp. Ceiling in the main space appears to be of the era/type to possibly have asbestos, but there is no known hazardous material survey.
- b. Recommended Action: Hire an independent specialist to survey the facility for hazardous materials prior to any renovations or demolition.
- c. Time Frame: TBD
- d. Opinion of Probable Construction Cost: TBD.
- e. See image #11

Significant mold damage present at foundation wall. Evidence of long duration and continued water infiltration. Foundation waterproofing or drain tile would be first necessary remediation. Ramp does not have required clearances, handrails, or non-slip flooring material.

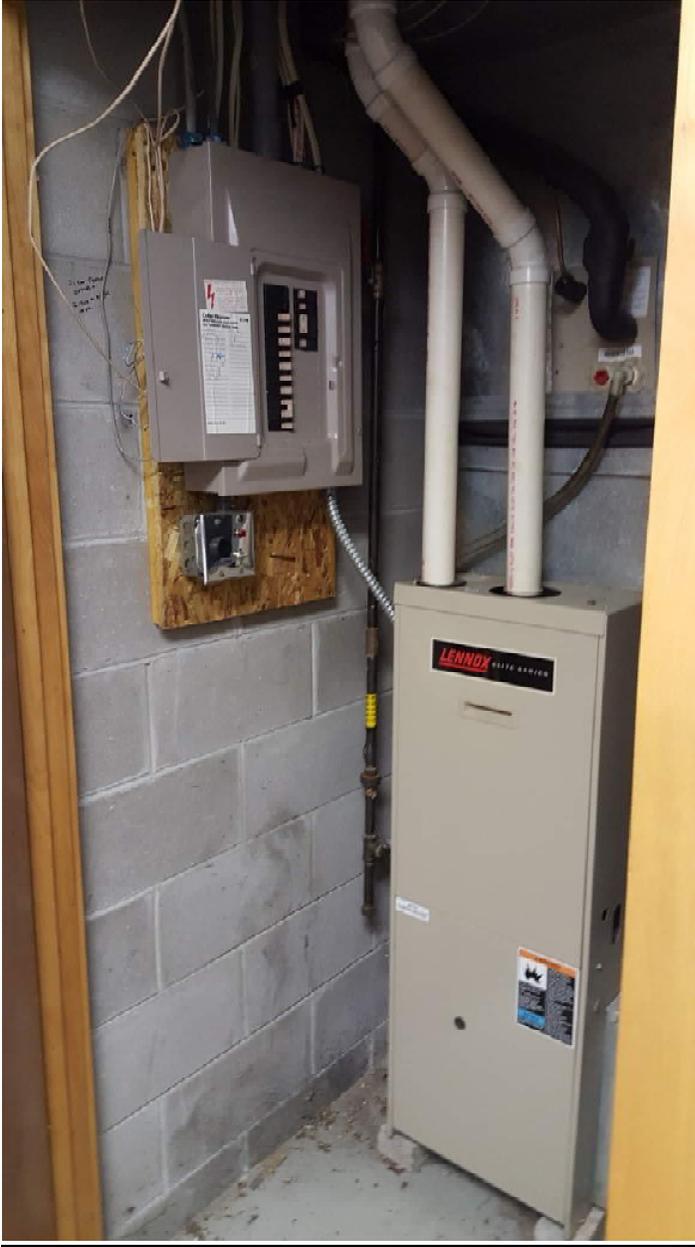
Furnace

Electrical panel mounted over furnace. Insufficient clearance at electrical panel.

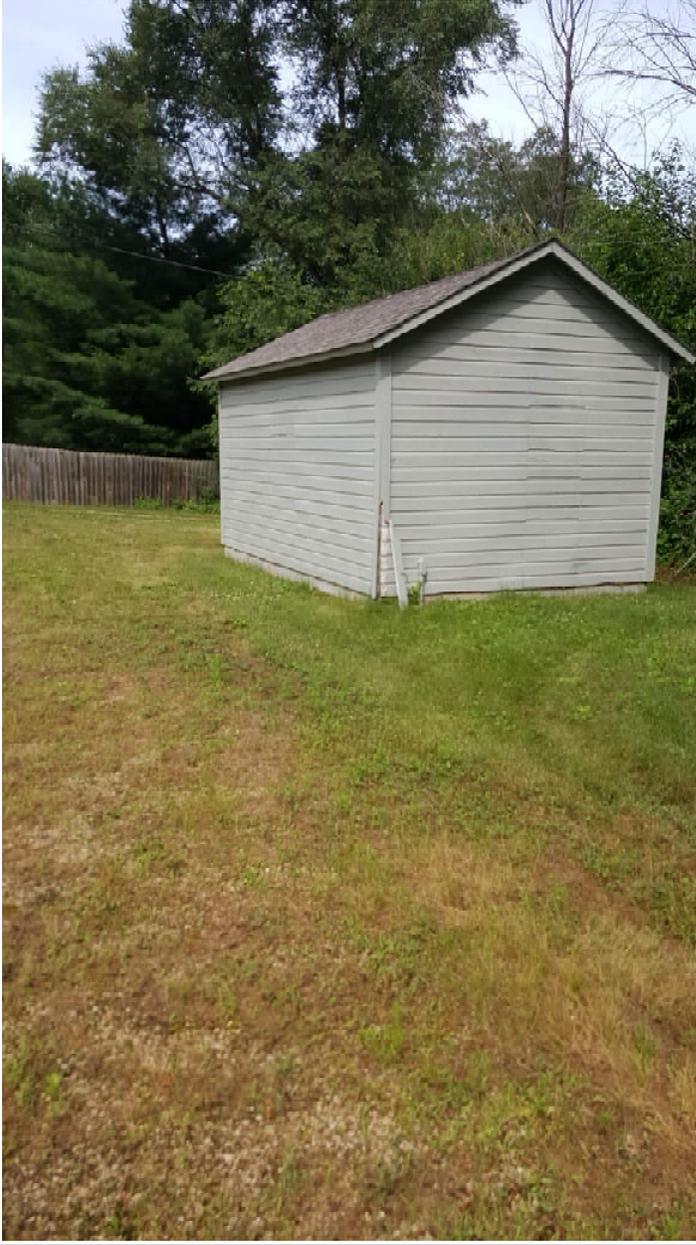
Existing Shed

Some visible damage

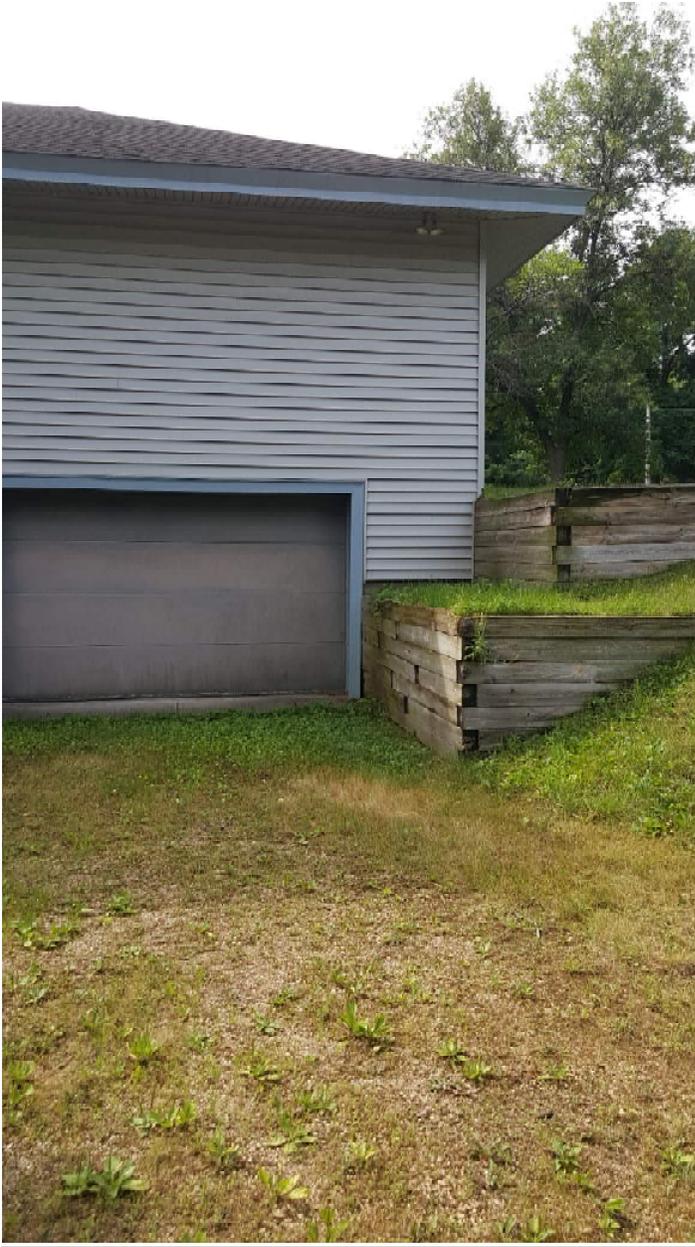
Existing Exterior

Wood retaining walls are still holding. Parking and sidewalks required at this area if it will be used as a public entrance.

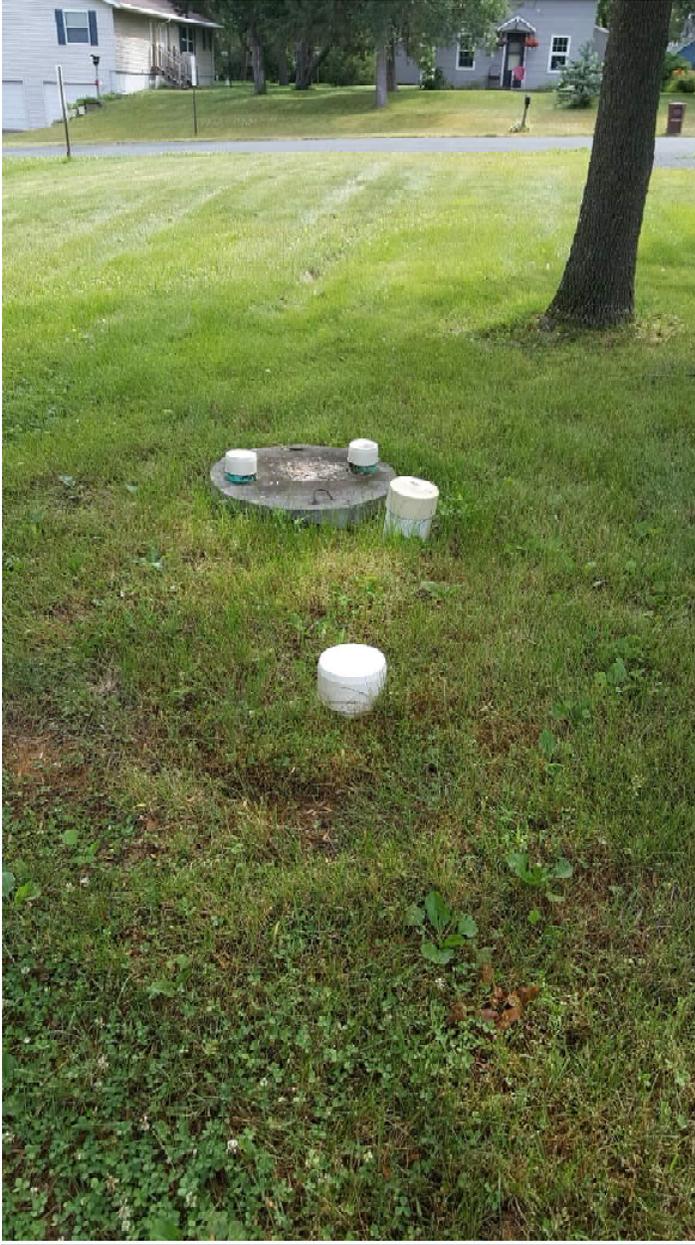
Existing Septic at Grade

Septic system evaluation not included in this scope of work. If this facility is to be renovated or added on to, a specialist needs to be engaged to do a detailed investigation/analysis of capacity and code-compliance on the septic system.

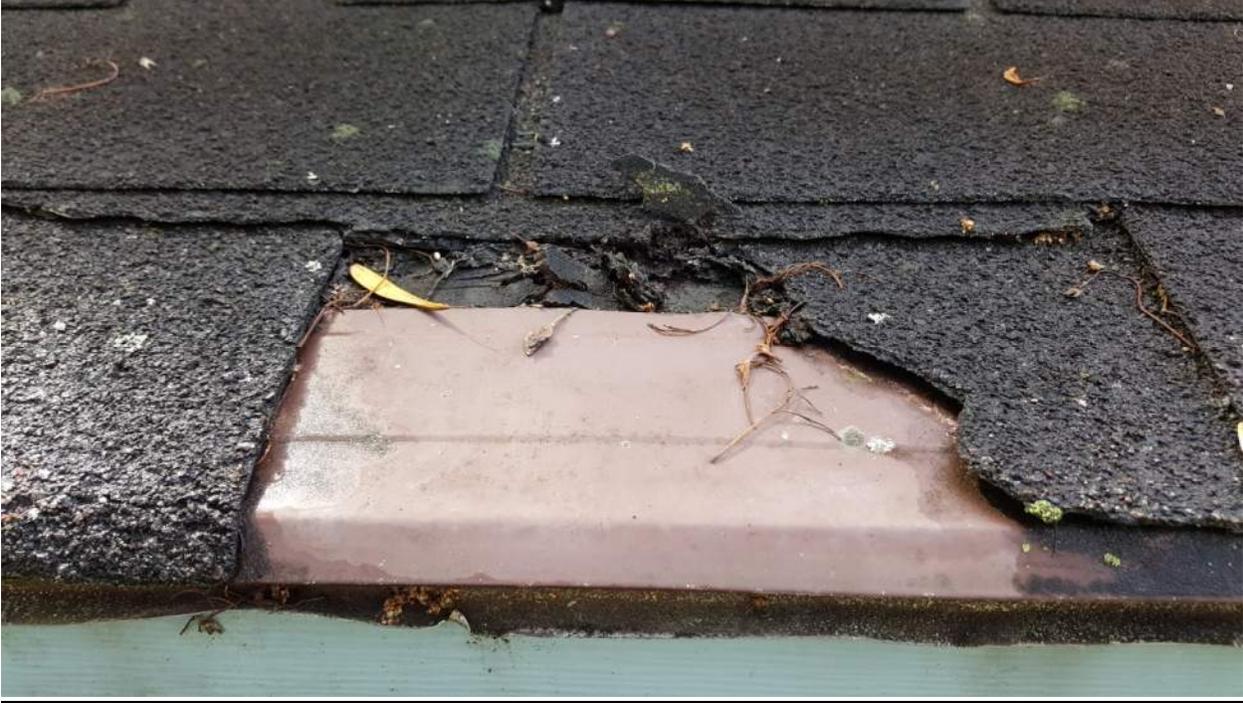
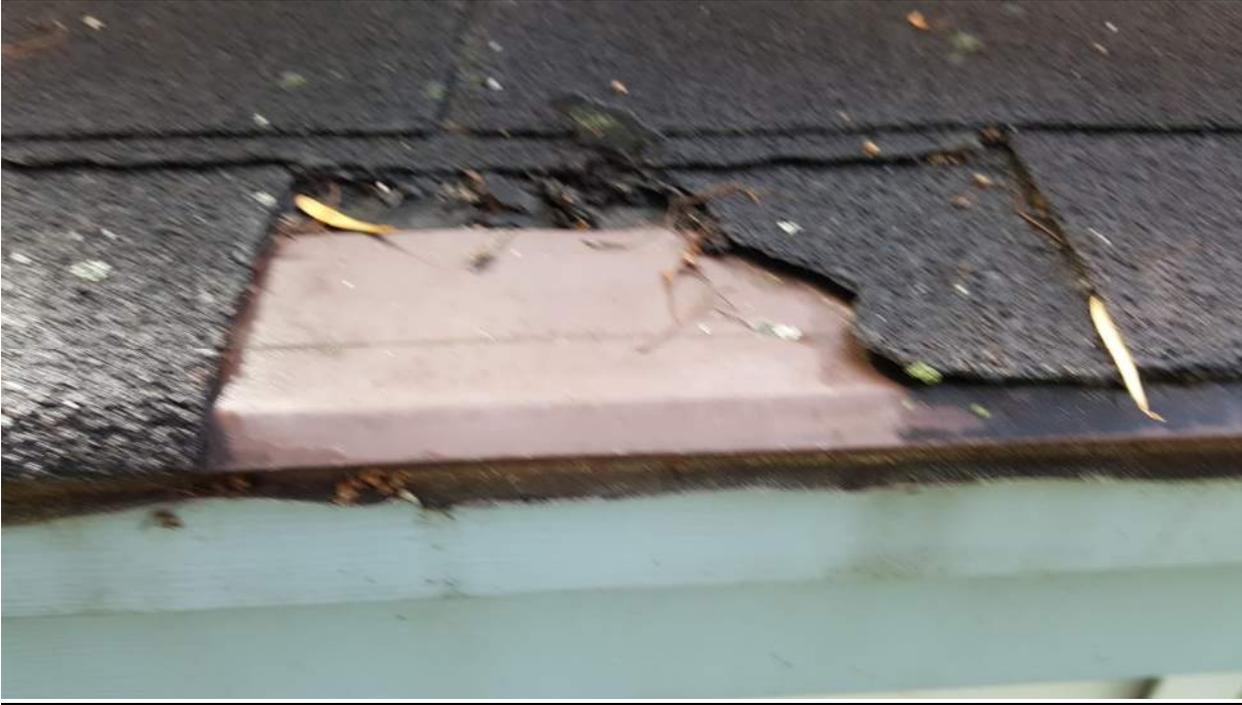
Existing Roof Damage at Lower Level Restrooms

3. Roofing:
 - a. The roof system appears to be at the end of its useful life. There are several areas, most notably over the lower level bathroom addition and the main office entry, where shingles show significant deterioration. At the bathroom addition you can push through both the shingles and the sheathing, so there is potential that lack of maintenance on the roofing has caused deterioration in the sheathing, fascia boards, or other elements that are currently concealed.
 - b. Recommended Action: Remove and replace roofing.
 - c. Time Frame: Immediately.
 - d. Opinion of Probable Construction Cost: \$7,000 (pending no sheathing/roof structure repairs are required).
 - e. See images #18, 19, 20, 26

Shingles missing, wood substrate substantially deteriorated. Remaining shingles at the end of their useful life.

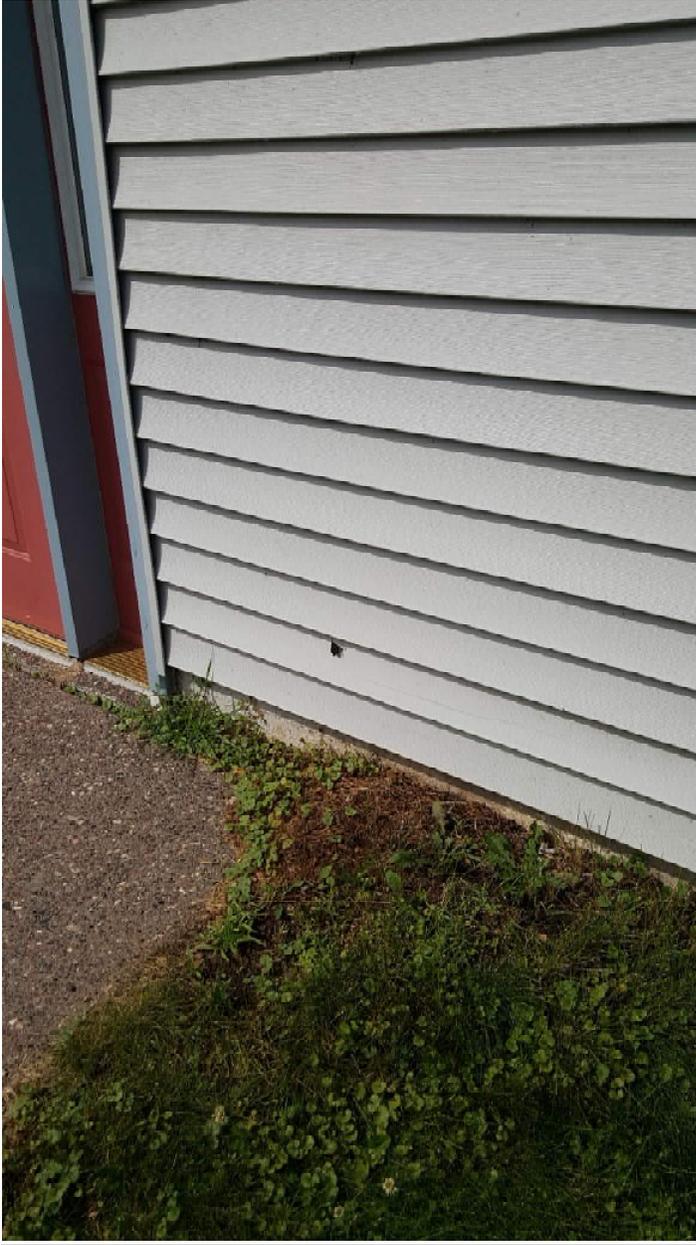
Exiting Exterior

- a. The vinyl siding around the building is severely damaged in several locations. There is no documentation immediately available as to when the siding was installed, as it was not part of the 1986 addition. In the worst damage location, you can see the wood siding called for in the 1986 drawings showing through, and damage to the foam/fiberglass product that was used between layers. There are many locations where rocks from a lawnmower have fully penetrated and broken the vinyl siding.

Lawnmower damage visible in vinyl siding.

- b. Recommended Action: Due to the lack of maintenance and the potential for water infiltration at the areas of roof deterioration, the recommendation would be to re-side the entire facility. Steel siding would be the least expensive option, with fiber cement siding the most desirable and expensive option. The longer that water has a way into the building through the envelope, the quicker it will deteriorate. Right now water can be trapped in the wall through the damaged siding and roofing.

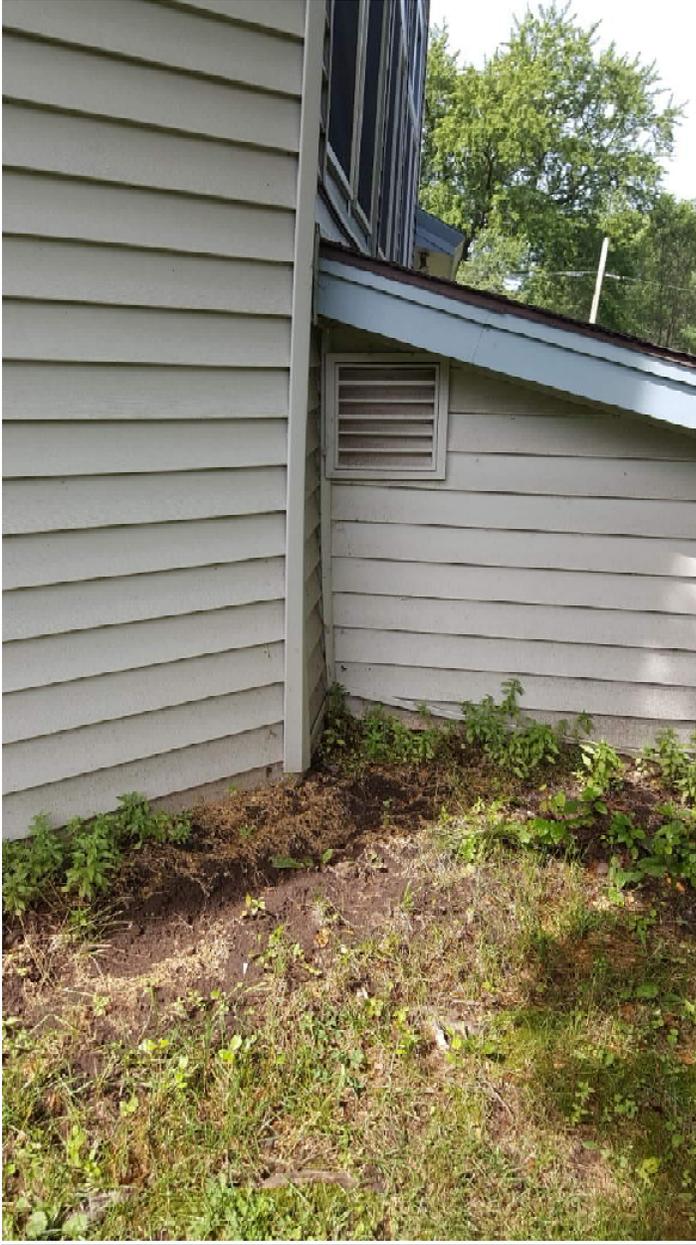
Existing Exterior

4. Gutters and Downspouts:
 - a. Gutters and downspouts appeared in decent condition. Most of the building does not currently have gutters and downspouts around it, which may contribute to the moisture problems evident in the lower level.
 - b. Recommended Action: Replace gutters at time of roofing replacement. Consider adding gutters and downspouts to the remainder of the building perimeter.
 - c. Time Frame: At time of roofing replacement.
 - d. Opinion of Probable Construction Cost: \$1,000 for replacement only.
 - e. See images #14, 15, 16, 18, 19, 22, 25, 26

Grade adequate, lack of buffer and gutters shows evidence of water falling near foundation. Potential contributor to the basement issues.

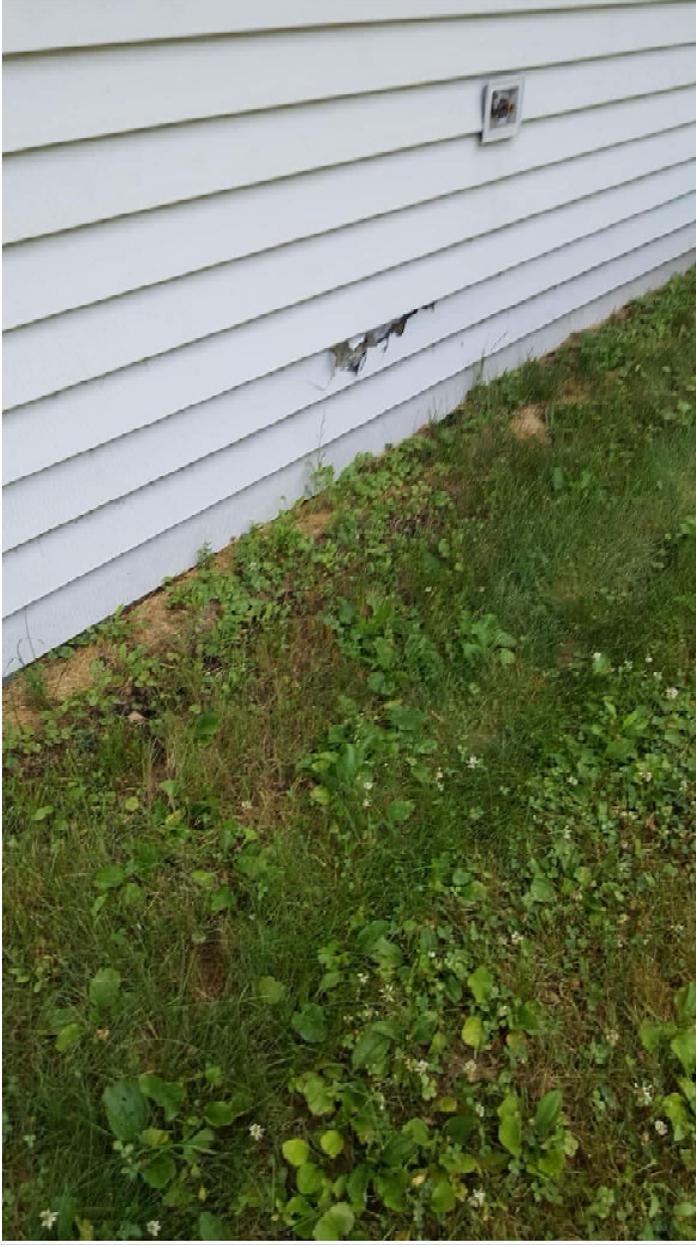
Existing Exterior

Significant damage to vinyl siding from lawnmower. Wood siding from 1986 addition visible to exterior, and potentially water damaged. Insulation board at opening is damaged/missing.

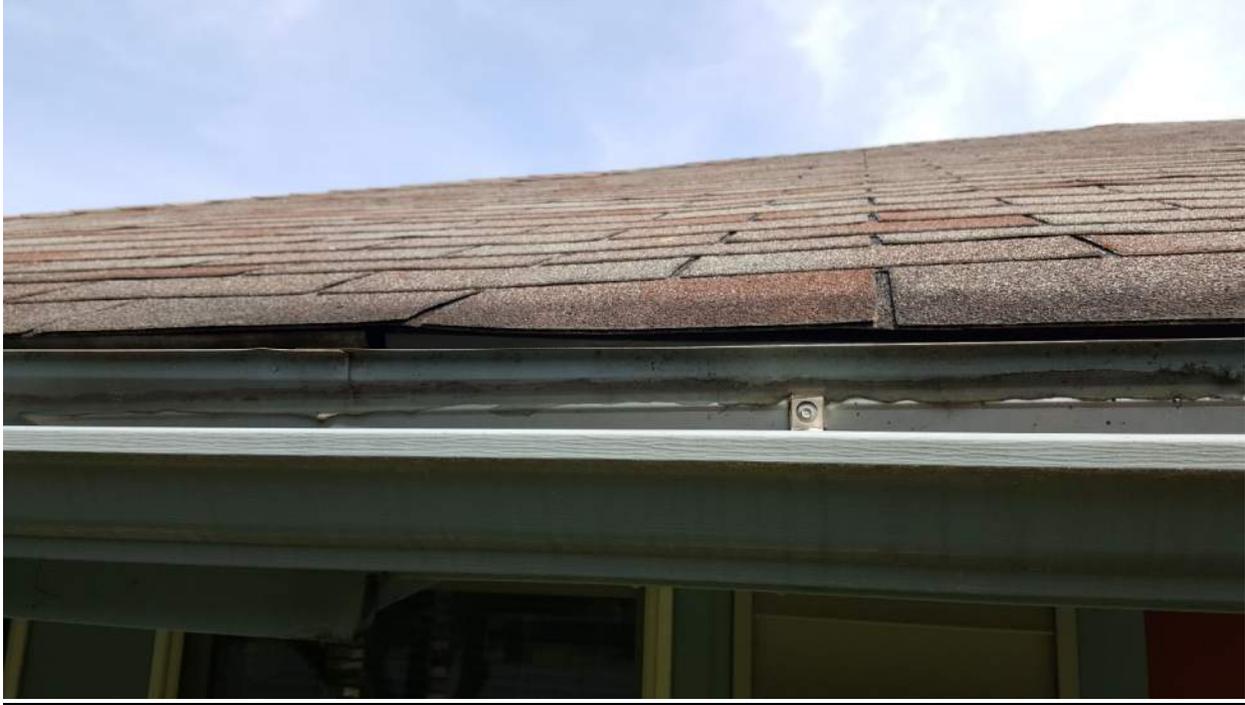
Existing Roof at Office Entry

Evidence of water/frost getting under shingles and damaging substrates. Shingles and gutters at the end of their useful lives.

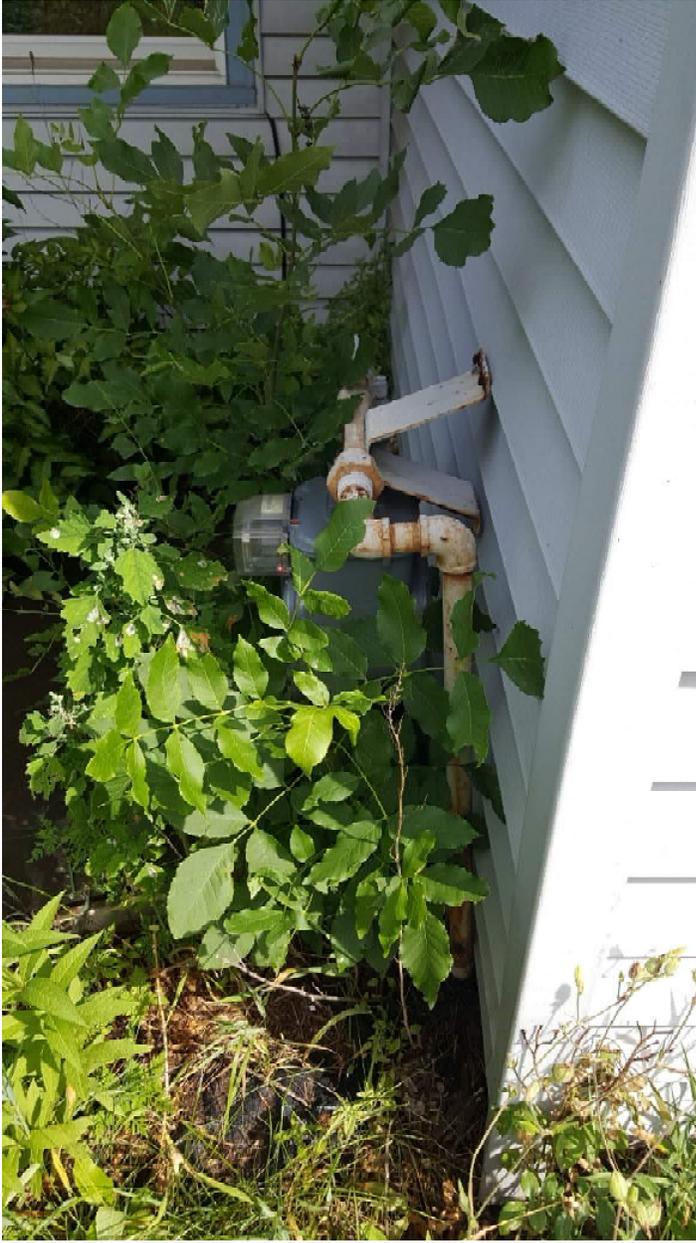
Gas Meter

Lack of exterior maintenance.

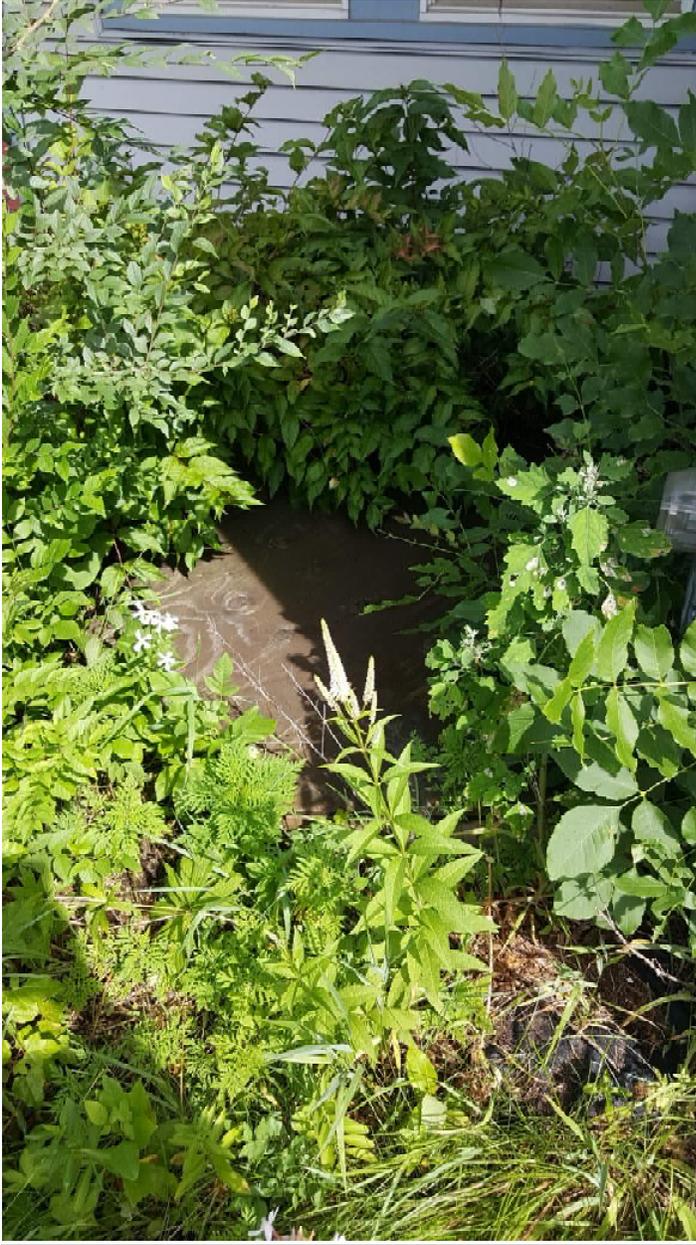
Existing Well Cover

6. Abandoned Well:
 - a. There is an abandoned well on site. Council Member Glasgow as unsure of the time and manner in which it was abandoned, and if it was properly capped. Further verification needed. This location restricts future additions to this portion of the building unless it is completely removed. Council currently replaces plywood cover as needed.
 - b. Recommended Action: If existing City Hall is to be renovated, a well specialist/contractor needs to be engaged to ensure proper handling.
 - c. Time Frame: TBD
 - d. Opinion of Probable Construction Cost: None at this time.
 - e. See image #28.

Plywood cover continually replaced as required by City. No known record if well was properly removed or capped. Prohibits expansion to this direction of the building.

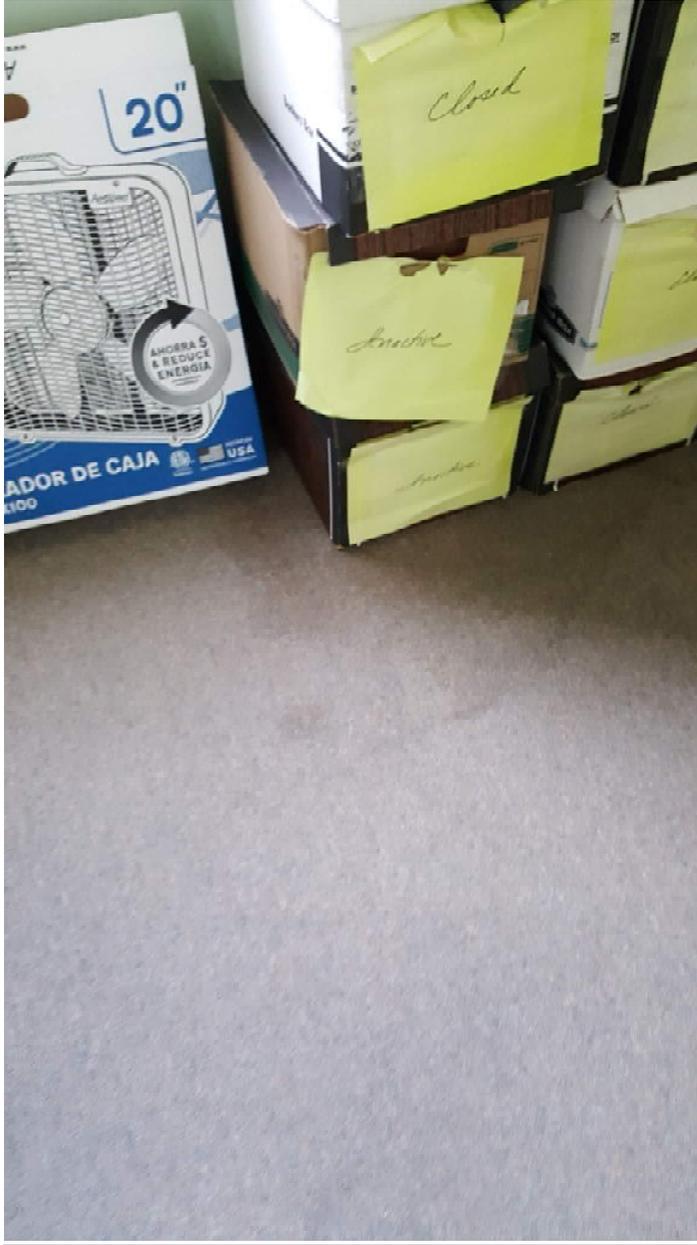
Existing Office Space

- a. The two existing offices spaces are in fair condition. In the office immediately adjacent to the Council Chambers, there is evidence of foundation settling and/or water damage to the floor structure due to uneven floor sheathing. The carpet and structure moves when stepped on.
- b. Recommended Action: Remove and replace flooring. Investigate cause of floor issue when exposed at flooring demo.
- c. Time Frame: TBD
- d. Opinion of Probable Construction Cost: \$500 for flooring only.

Evidence of floor structure damage. This area is soft to the step, so differential settling of the foundation or water damage is likely.

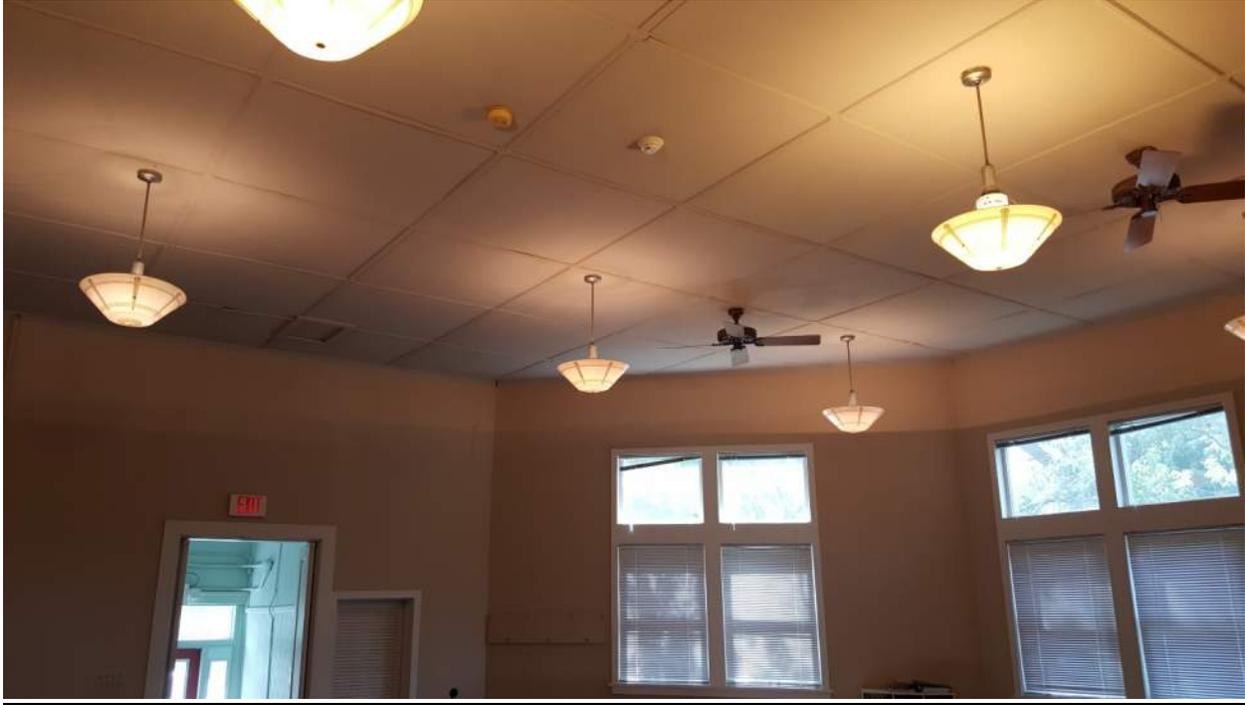
Existing Chambers Ceiling

Good condition.

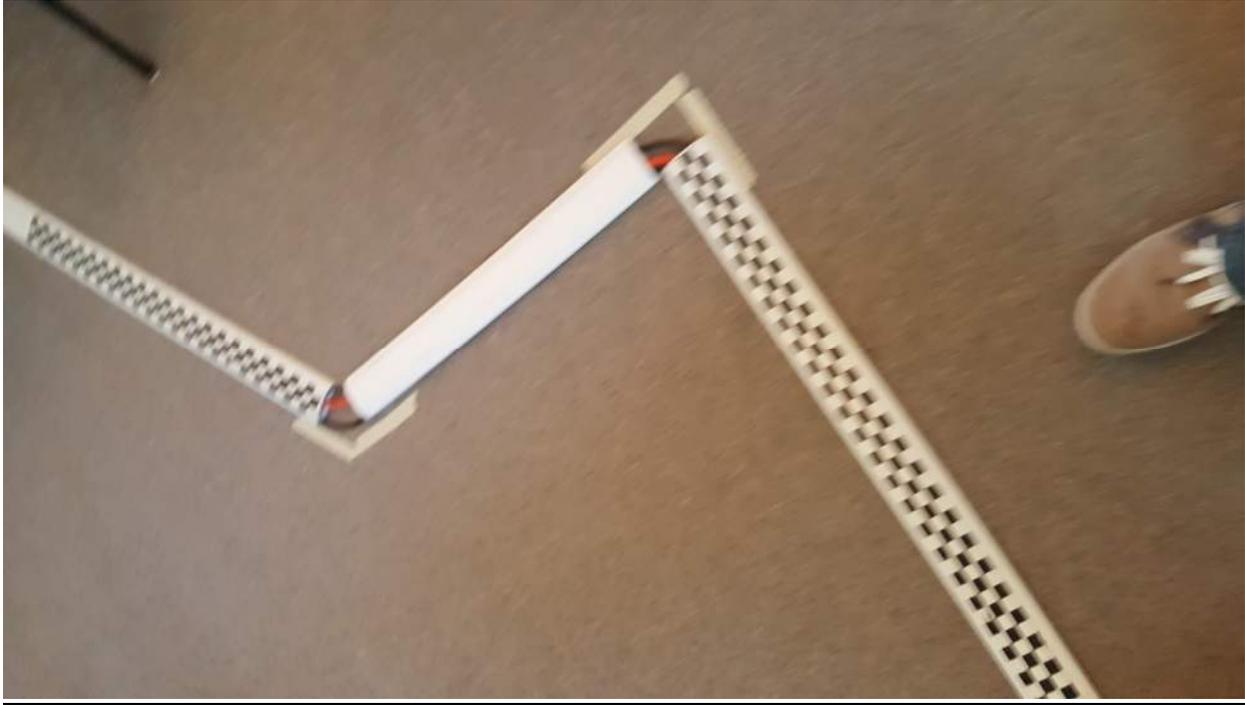
Floor Mounted Systems in Chambers

Trip hazard, lack of flexibility in retrofit of audio visual systems.

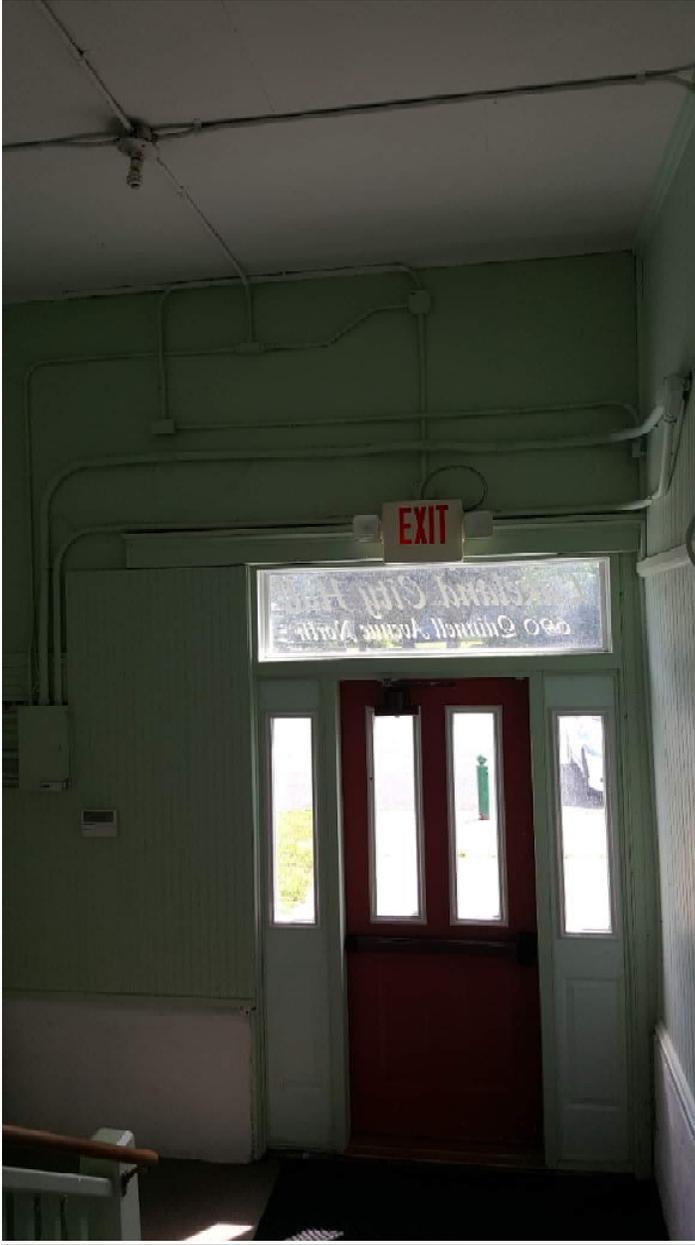
Existing Chambers Entry

- a. The condition of these spaces is acceptable, but there are many code deficiencies in all of these spaces. The stairs main public entry to Council Chambers do not have consistent riser heights or proper handrails. The accessible route is provided through the office entrance, but is no longer compliant with full ANSI/ADA guidelines. Following the doors in series requirements, the vestibule does not have the proper maneuvering clearances, the ramp is narrower than preferred and lacks handrails, and door hardware has not been modernized.

Stairs to not meet code for consistent riser height. Lack of proper handrails. No accessible entry. Finishes have reached the end of their useful lives. Surface mounted electrical systems.

- b. Recommended Action: Remove all storage items from path of travel. Since the clearances cannot be met within the constraints of the existing space, EAPC will recommend an addition to the Northeast of the building to provide a new accessible entry and route. This addition can include an office space and small conference room as well.
