**LAKELAND CITY HALL
CAPITAL NEEDS ASSESSMENT
(CNA AUDIT)**

DATE	JULY 15 th , 2016
NUMBER	20162641

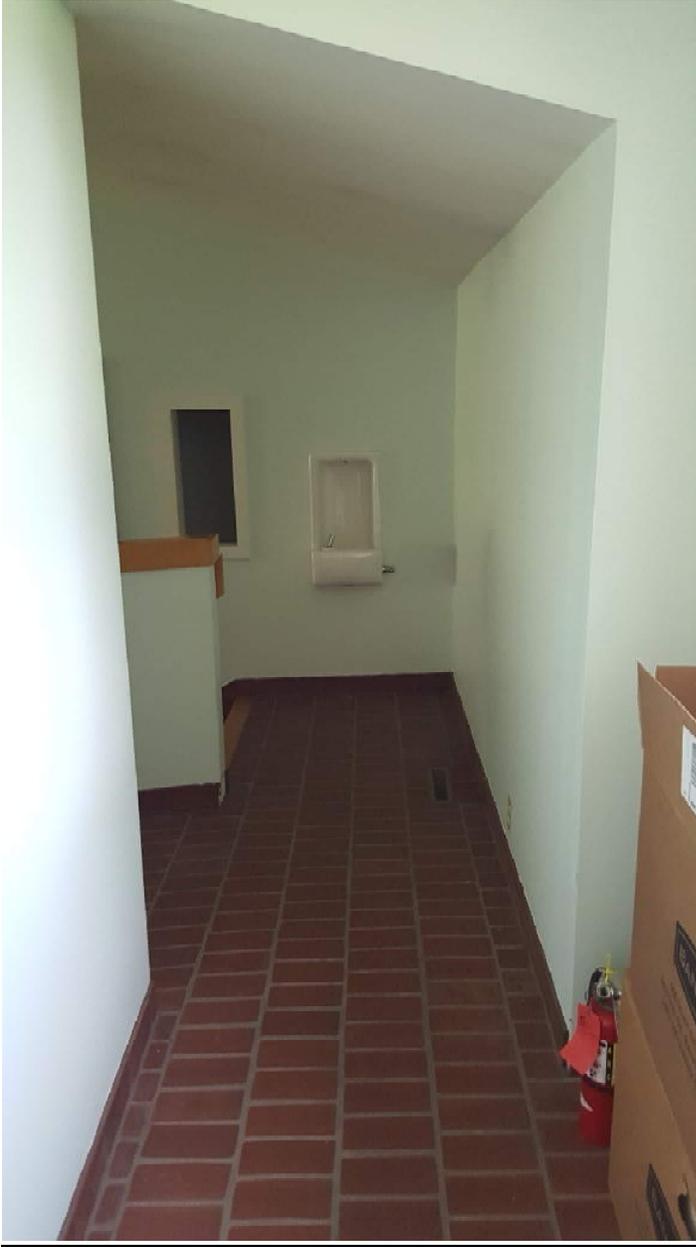
Main Level Corridor

Inadequate maneuvering clearances for accessible ramp.

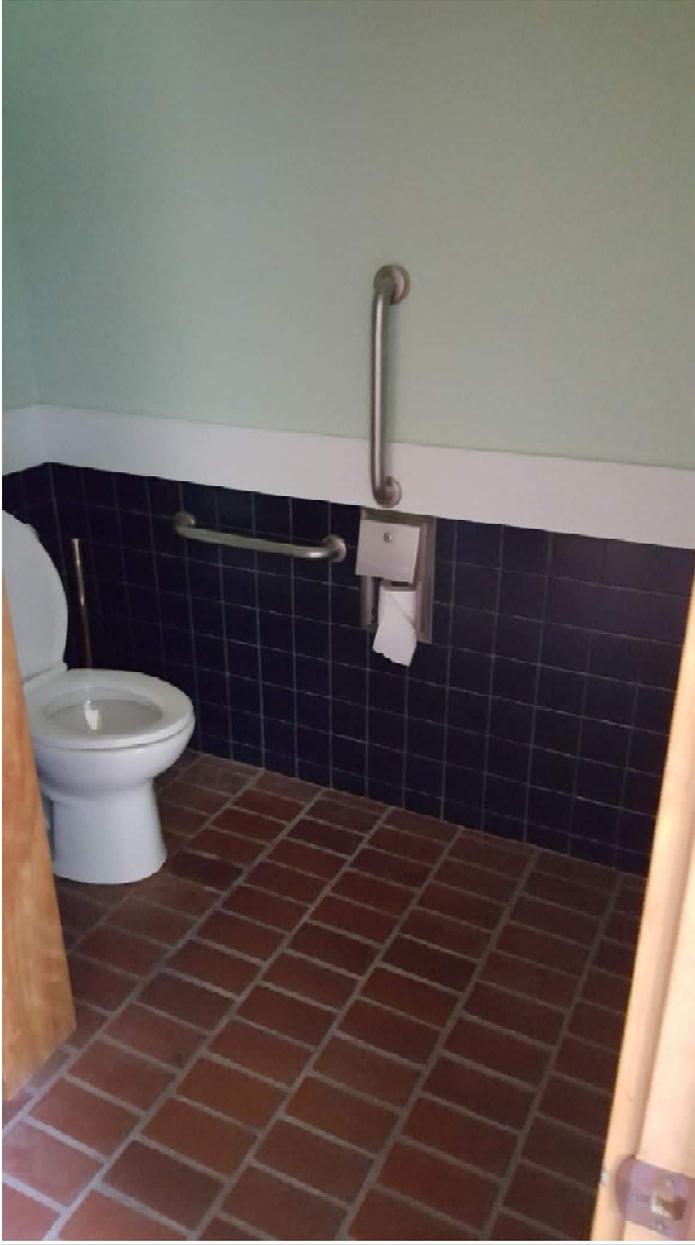
Main Level Restrooms

- a. Main level restrooms are in fair condition, but do not meet current accessibility code. There is both a lack of proper grab bars and insufficient space to provide adequate maneuvering clearances. It appears that the clearances will be difficult to achieve with the restroom in its current location. EAPC proposes an a renovation to this restroom for maintenance, but also the addition of a new fully-accessible restroom in the minor addition.
- b. Recommended Action: Remodel existing restroom. Add restroom in planned addition.
- c. Time Frame: TBD
- d. Opinion of Probable Construction Cost: \$4,000 for restroom remodel. See executive summary for addition costs.
- e. See image #35, 36.

Inadequate maneuvering clearances for ADA compliance. Handrails non-compliant with current ADA requirements. Finishes nearing end of useful life.

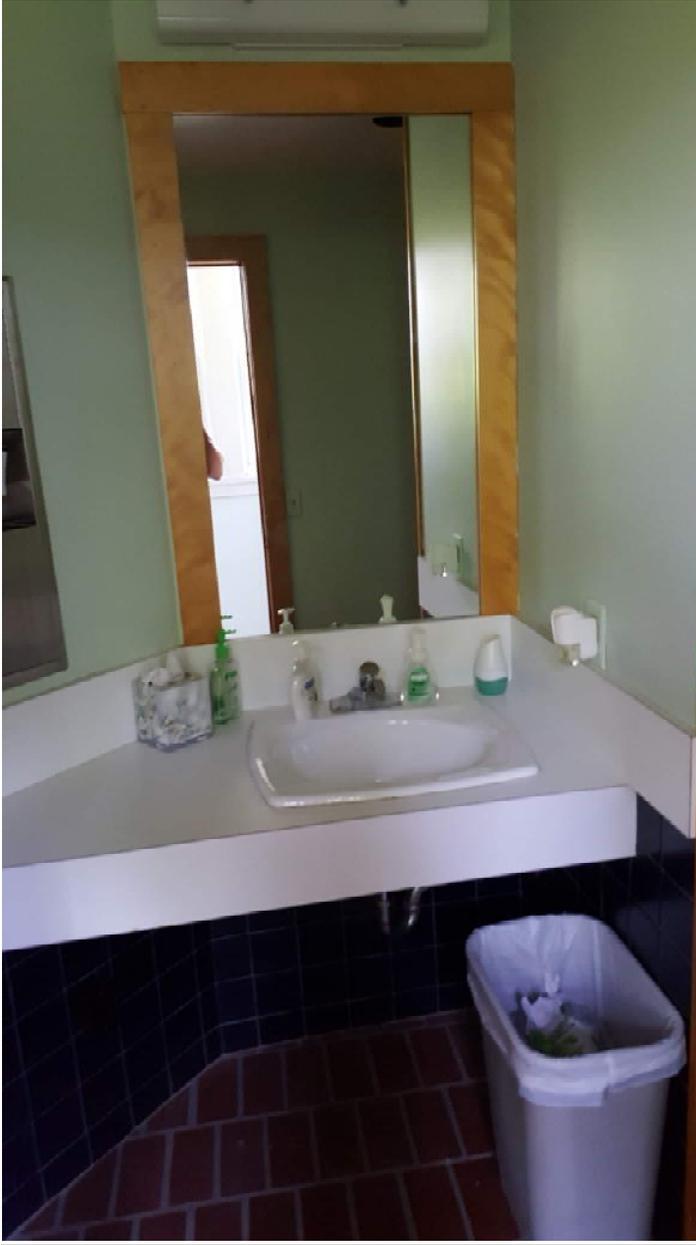
Main Level Restrooms

Sink approach non-compliant with ADA.

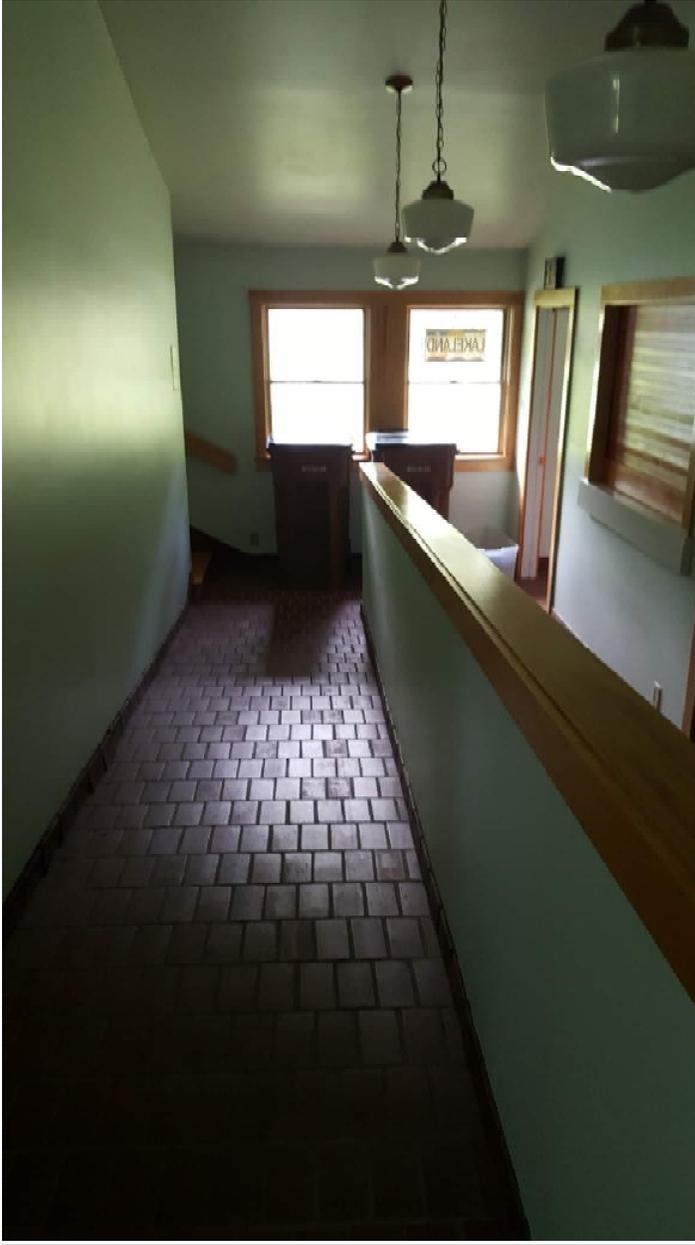
Handicap Ramp at Office Entry

Ramp lacks adequate handrails and maneuvering clearances at each end. Flooring material not ideal for handicap accessibility due to trip hazard with canes or walkers.

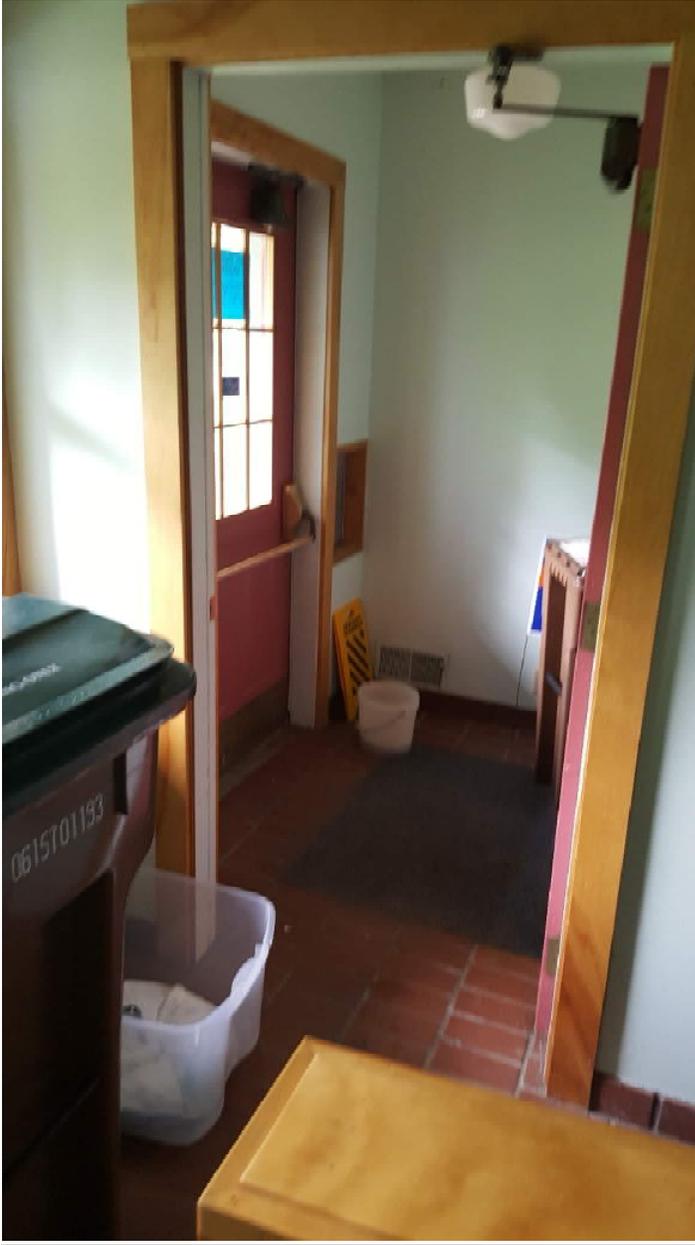
Office Entry

Lack of proper clearances for doors in series per ADA. Space being used for storage of garbage and recycling further compromises clearance issues. Door hardware is outdated for egress and security.
