**LAKELAND CITY HALL
CAPITAL NEEDS ASSESSMENT
(CNA AUDIT)**

DATE	JULY 15 th , 2016
NUMBER	20162641

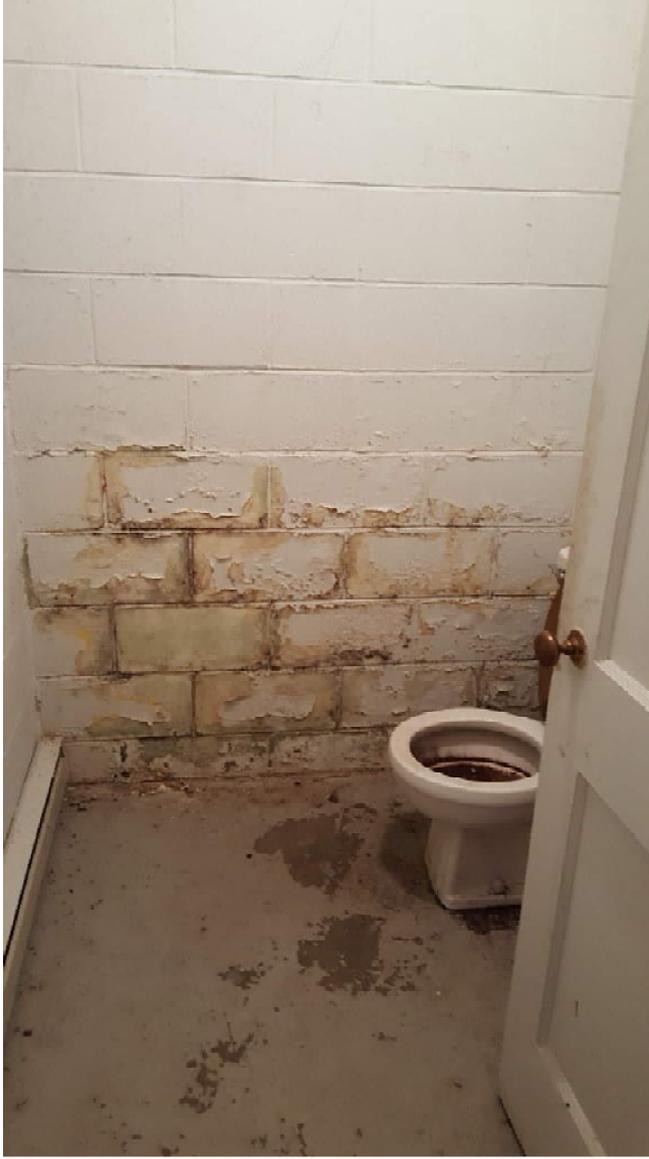
Bathroom

Fixtures damaged beyond repair. Significant water damage through wall and roof in this area. Potential for structural issues with CMU wall. ADA space clearances not available or met.
